St Tammany Parish, LA

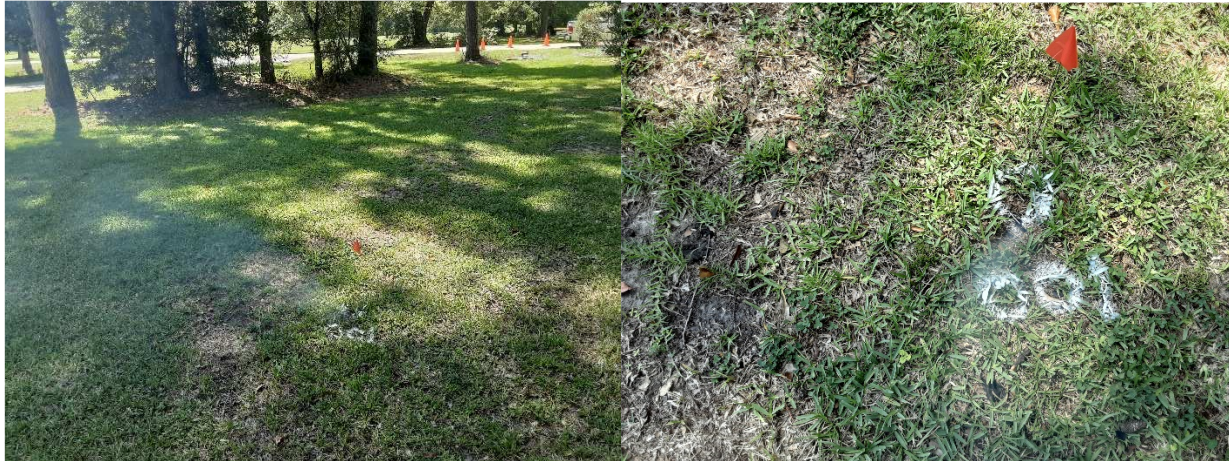
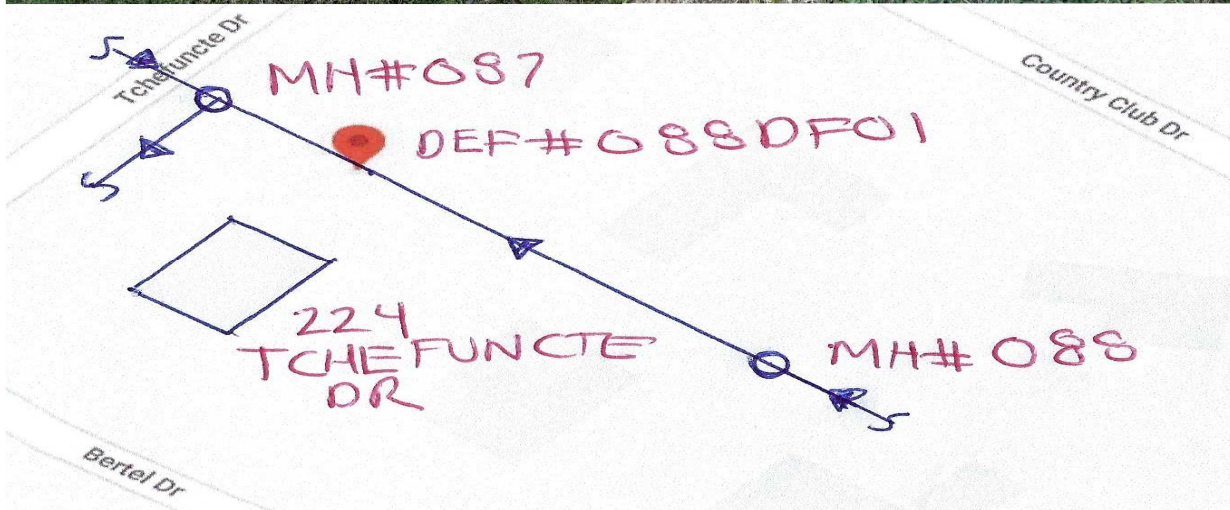
DEFECT NO.: 01	AREA PHOTO NO.: 06-088DF01A	GPS PHOTO NO.: 06-088DF01G
DEFECT TYPE: Broken Cleanout	SMOKE INTENSITY: Medium	INFLOW POTENTIAL: Moderate
SURFACE LOCATION: Back Yard	SURFACE MATERIAL: Sod/Dirt	ADDRESS: 224Bertel Dr.
ACCESSIBLE TO DEFECT: Private Property	NORTHING: 698415.19600	EASTING: 3669382.32700
COMMENTS:

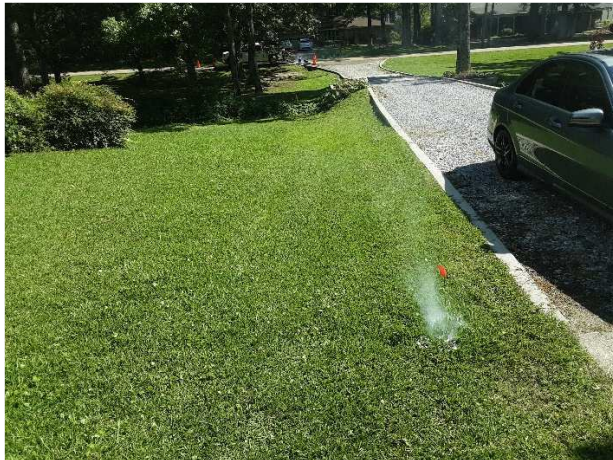
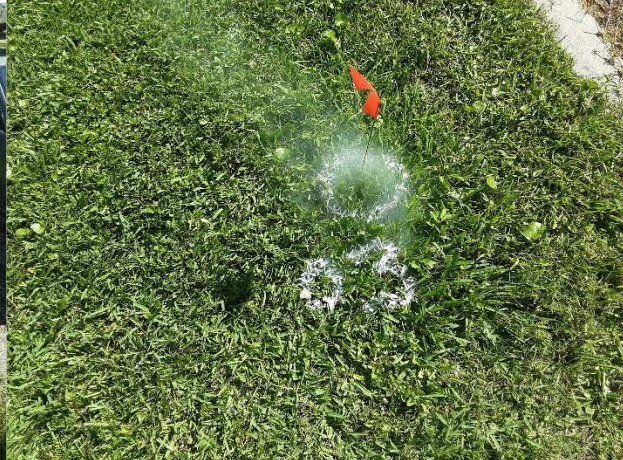
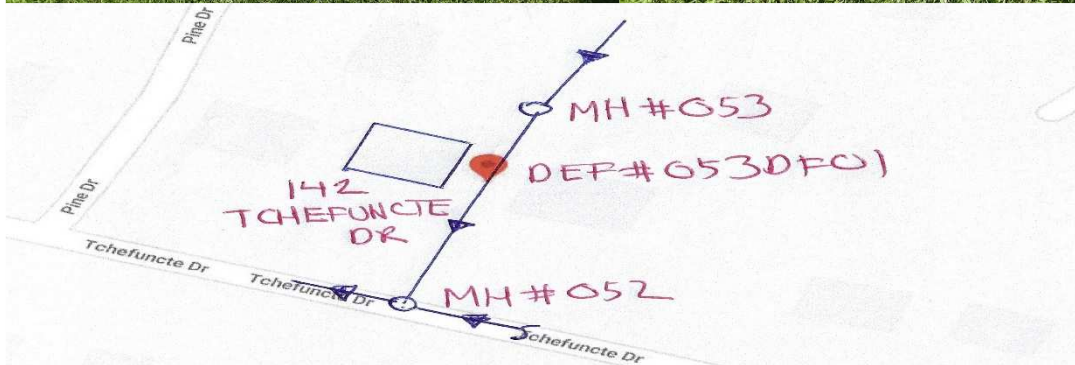
DEFECT NO.: 01	AREA PHOTO NO.: 06-053DF01A	GPS PHOTO NO.: 06-053DF01G
DEFECT TYPE: Mainline	SMOKE INTENSITY: Medium	INFLOW POTENTIAL: Moderate
SURFACE LOCATION: Yard	SURFACE MATERIAL: Sod/Dirt	ADDRESS: 142Tchefuncte Dr.
ACCESSIBLE TO DEFECT: Private Property	NORTHING: 696231.85600	EASTING: 3672153.04100
COMMENTS:

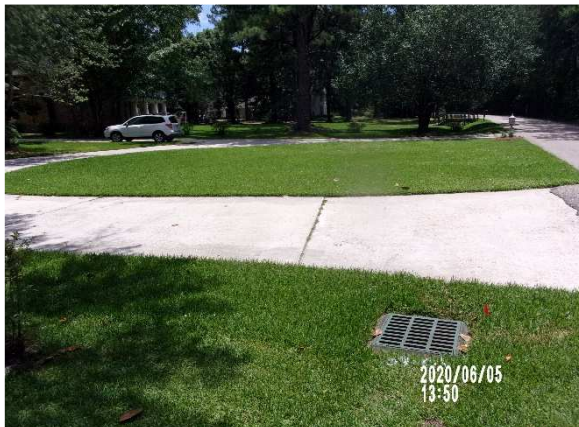
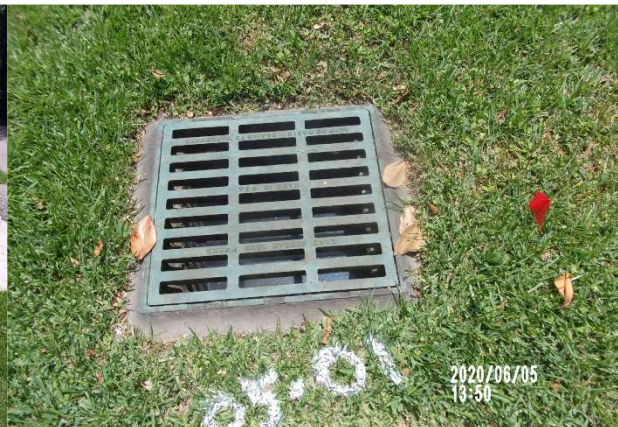
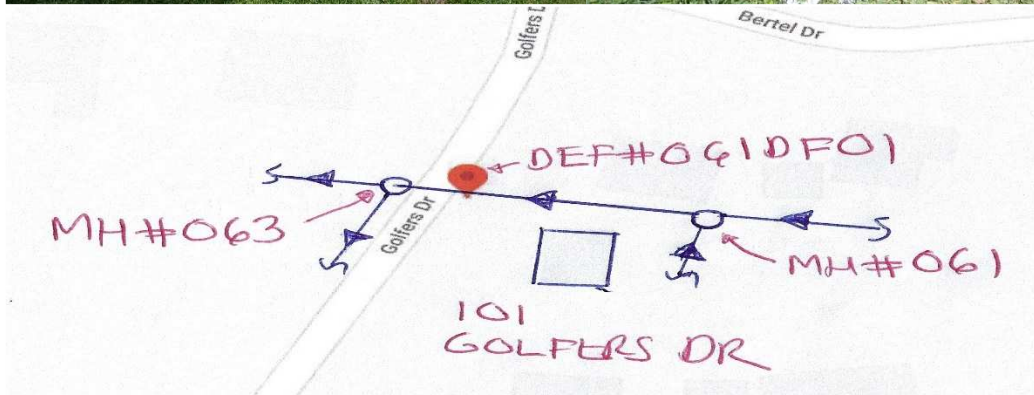
DEFECT NO.: 01	AREA PHOTO NO.: 06-061DF01A	GPS PHOTO NO.: 06-061DF01G
DEFECT TYPE: Direct Storm Drain	SMOKE INTENSITY: Thick	INFLOW POTENTIAL: Severly
SURFACE LOCATION: Road Shoulder	SURFACE MATERIAL: Sod/Dirt	ADDRESS: 101 Golfers Dr.
ACCESSIBLE TO DEFECT: Public Property	NORTHING: 697402.03000	EASTING: 3671458.31700
COMMENTS:

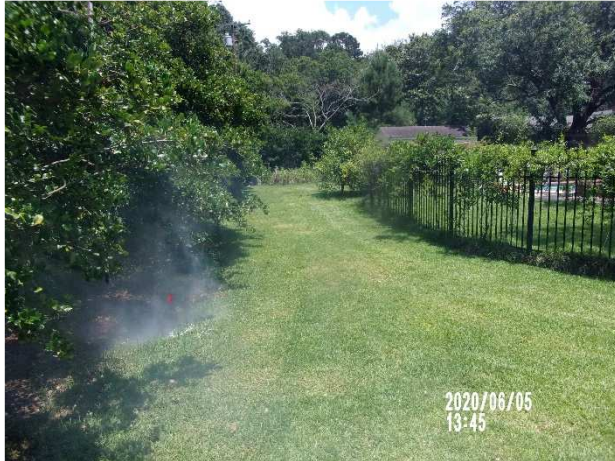
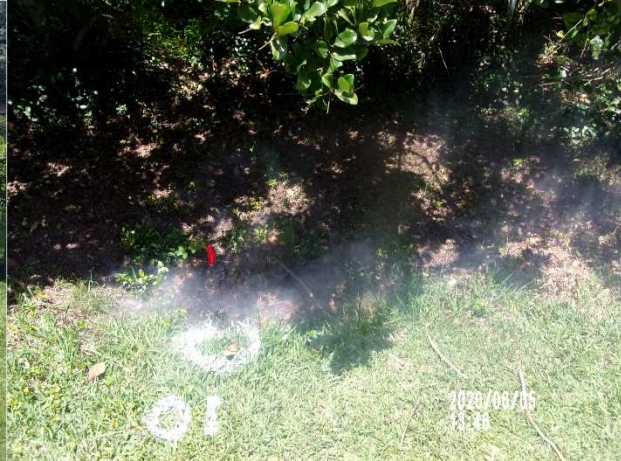
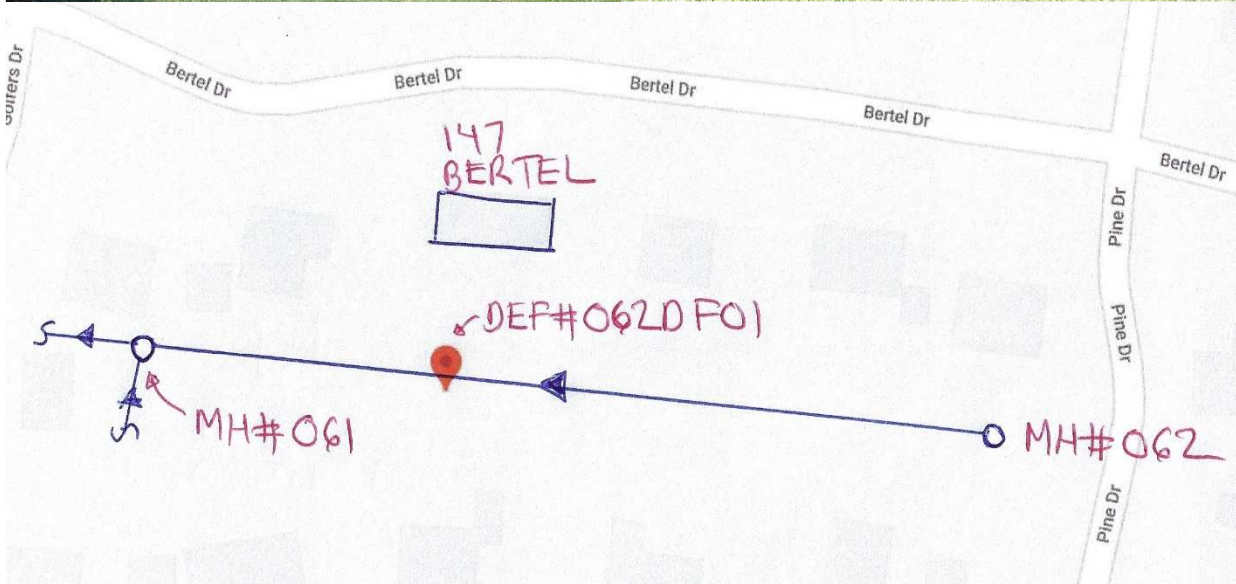
DEFECT NO.: 01	AREA PHOTO NO.: 06-062DF01A	GPS PHOTO NO.: 06-062DF01G
DEFECT TYPE: Multiple Leaks	SMOKE INTENSITY: Medium	INFLOW POTENTIAL: Heavy
SURFACE LOCATION: Easement	SURFACE MATERIAL: Sod/Dirt	ADDRESS: 147 Bertel Dr.
ACCESSIBLE TO DEFECT: Private Property	NORTHING: 697355.29700	EASTING: 3671812.07200
COMMENTS:

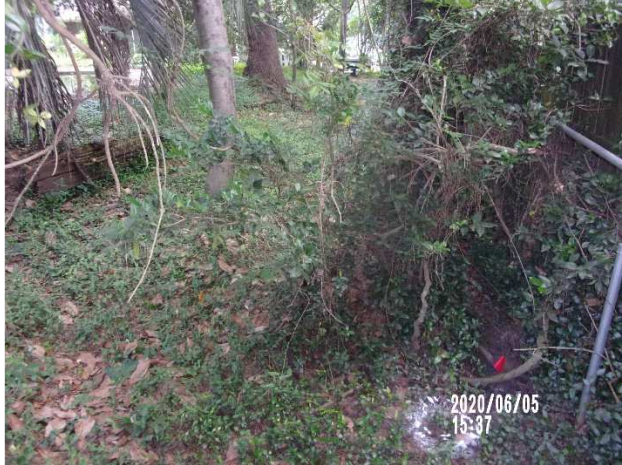
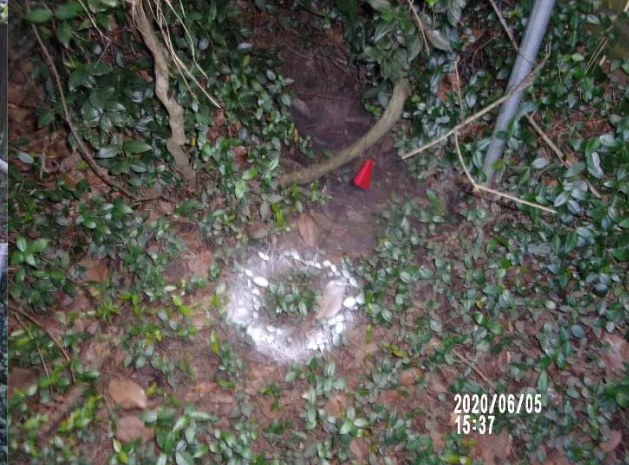
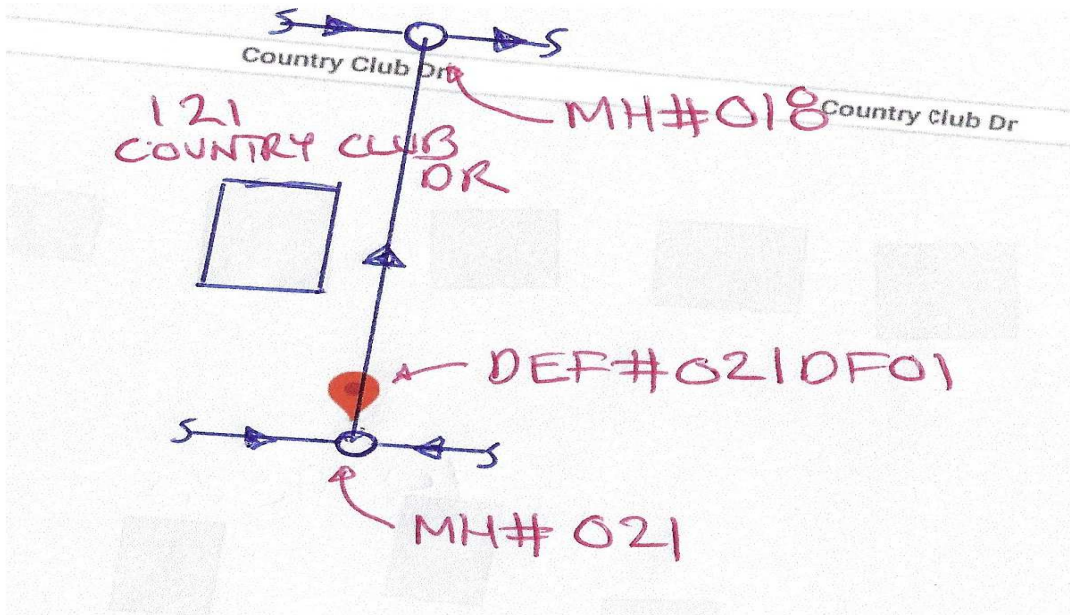
DEFECT NO.: 01	AREA PHOTO NO.: 06-021DF01A	GPS PHOTO NO.: 06-021DF01G
DEFECT TYPE: Hole	SMOKE INTENSITY: Light	INFLOW POTENTIAL: Moderate
SURFACE LOCATION: Back Yard	SURFACE MATERIAL: Sod/Dirt	ADDRESS: 121 Country Club Dr.
ACCESSIBLE TO DEFECT: Private Property	NORTHING: 697659.70100	EASTING: 3673374.44300
COMMENTS:

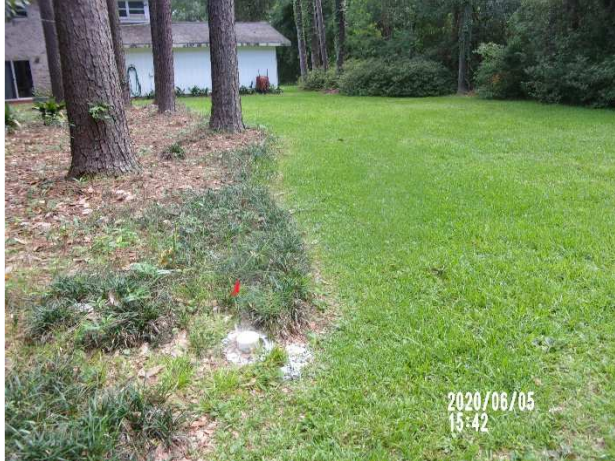
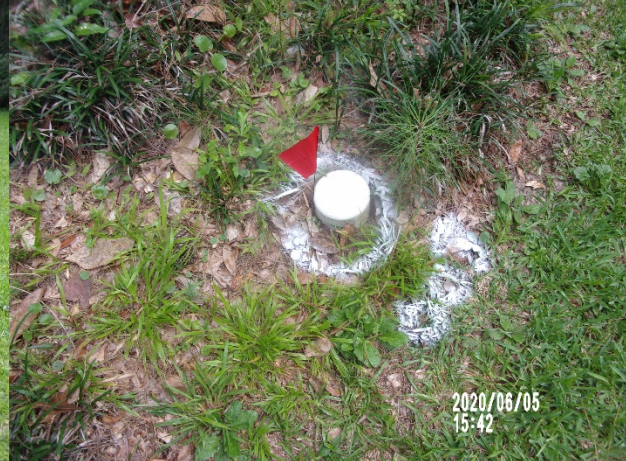
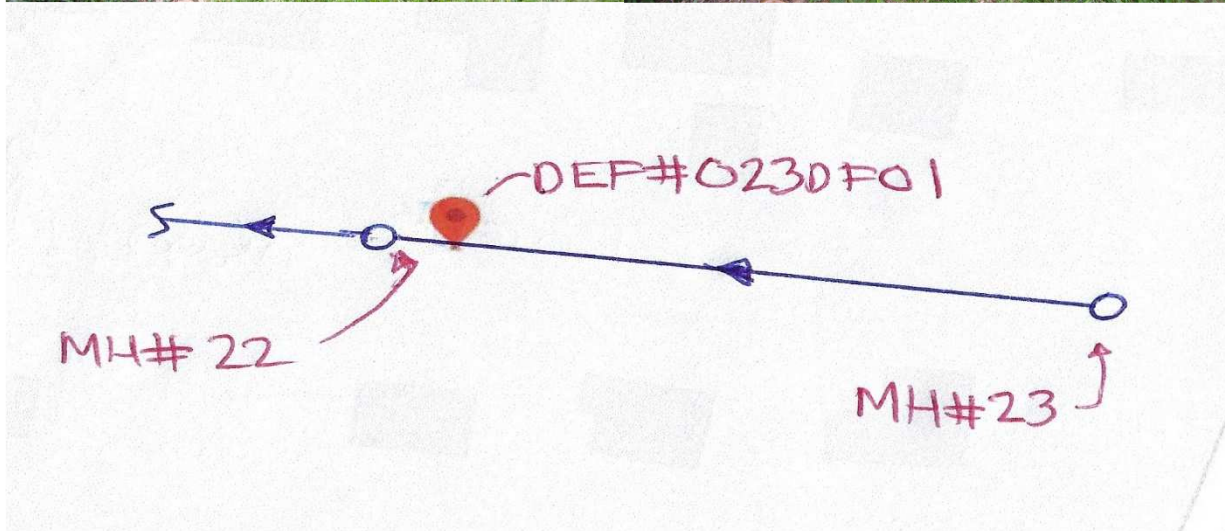
DEFECT NO.: 01	AREA PHOTO NO.: 06-023DF01A	GPS PHOTO NO.: 06-023DF01G
DEFECT TYPE: Cleanout Cap Broken	SMOKE INTENSITY: Light	INFLOW POTENTIAL: Chance is Slim
SURFACE LOCATION: Back Yard	SURFACE MATERIAL: Sod/Dirt	ADDRESS: 108 Bertel Dr.
ACCESSIBLE TO DEFECT: Private Property	NORTHING: 697586.13900	EASTING: 3673922.05000
COMMENTS:

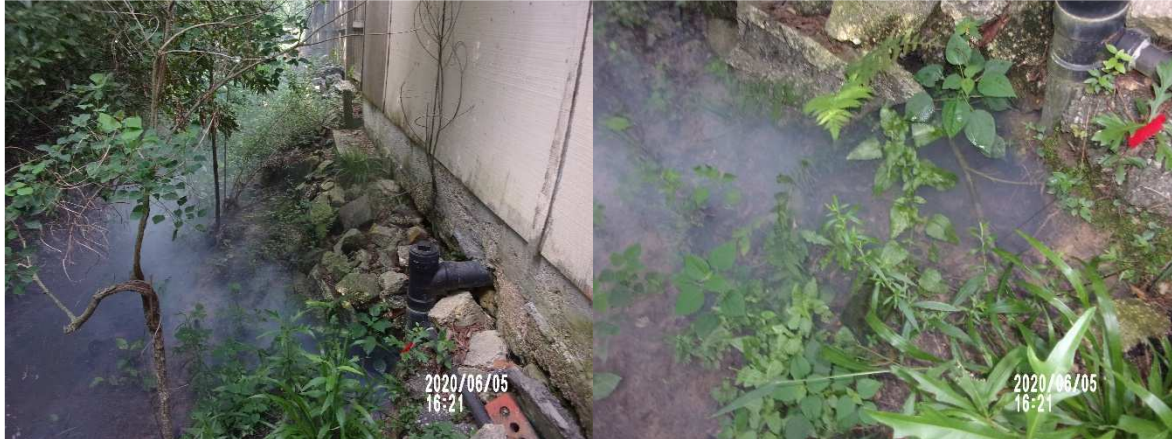
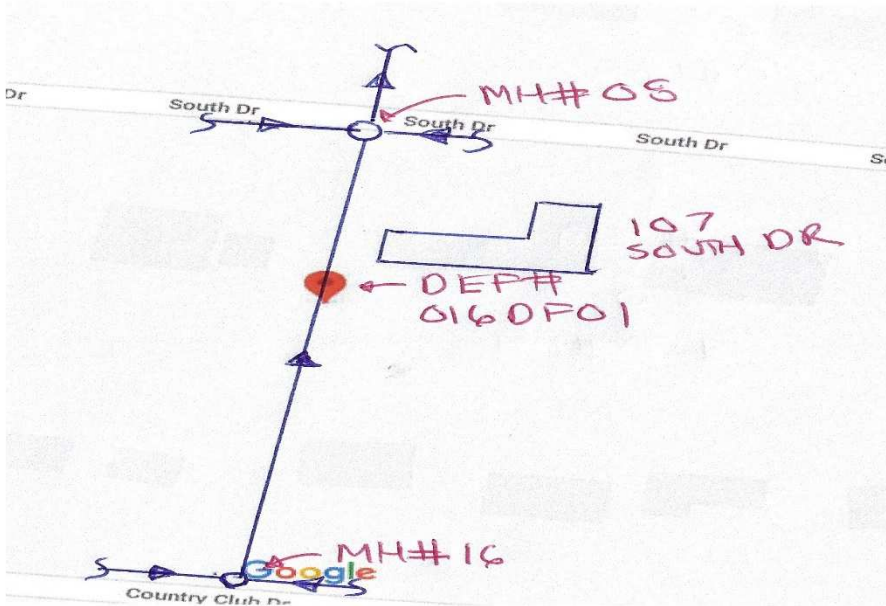
DEFECT NO.: 01	AREA PHOTO NO.: 06-016DF01A	GPS PHOTO NO.: 06-016DF01G
DEFECT TYPE: Hole	SMOKE INTENSITY: Thick	INFLOW POTENTIAL: Severly
SURFACE LOCATION: Drainage Ditch	SURFACE MATERIAL: Sod/Dirt	ADDRESS: 107 South Dr.
ACCESSIBLE TO DEFECT: Private Property	NORTHING: 698120.20700	EASTING: 3673921.54500
COMMENTS:

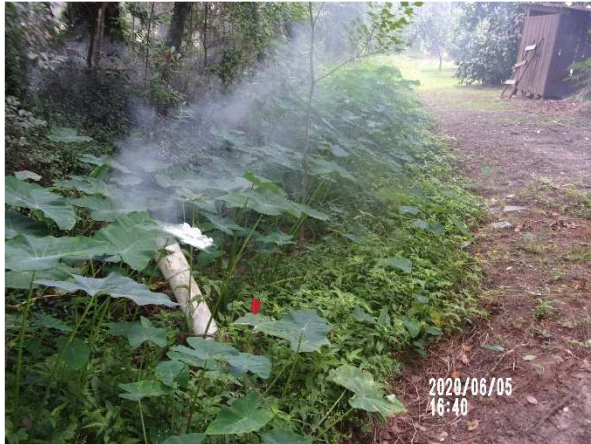
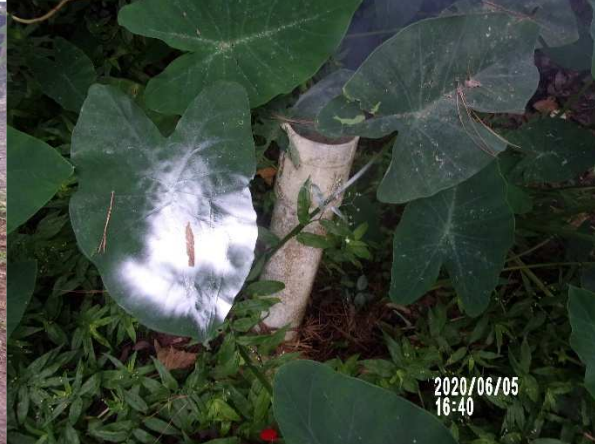
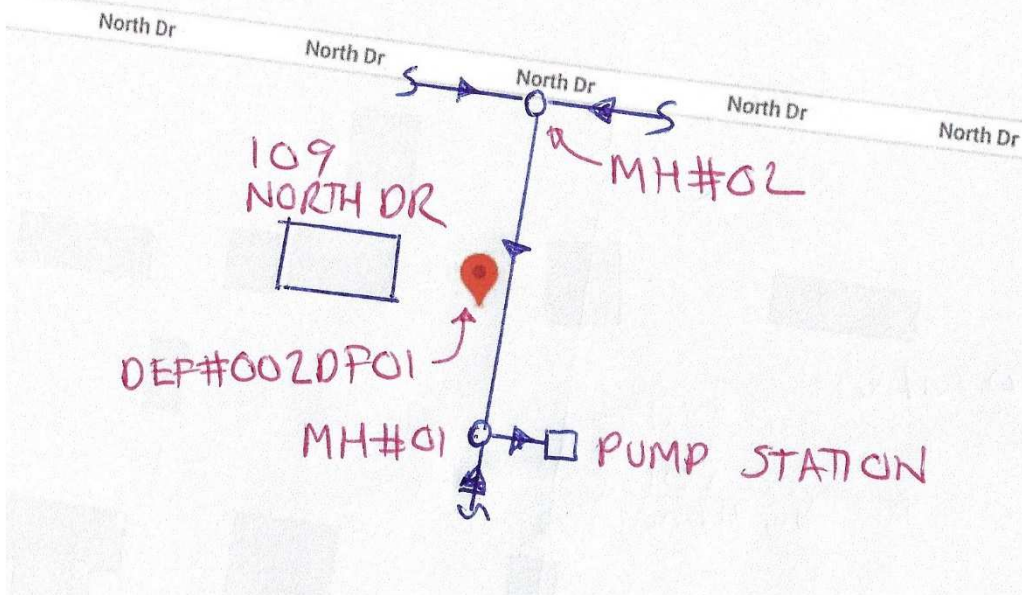
DEFECT NO.: 01	AREA PHOTO NO.: 06-002DF01A	GPS PHOTO NO.: 06-002DF01G
DEFECT TYPE: Missing Cleanout Cap	SMOKE INTENSITY: Thick	INFLOW POTENTIAL: Heavy
SURFACE LOCATION: Drainage Ditch	SURFACE MATERIAL: Sod/Dirt	ADDRESS: 109 North Dr.
ACCESSIBLE TO DEFECT: Private Property	NORTHING: 698625.26200	EASTING: 3673997.75400
COMMENTS:
